Casualty Investigations

Gambling with Safety

Allision of a towing vessel.

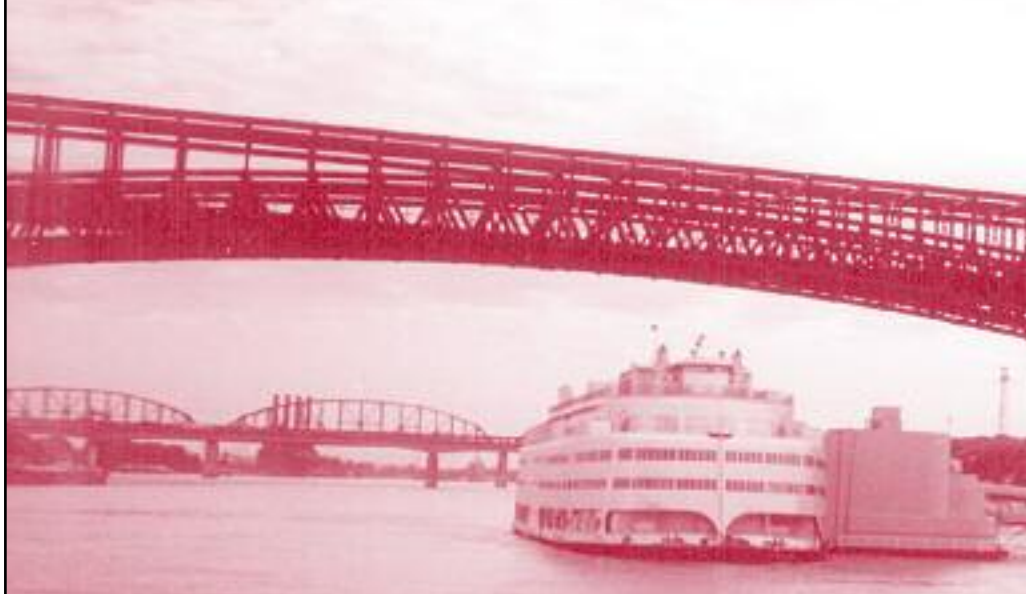
Just north of the St. Louis Gateway Arch on the Mississippi River, the 380-foot-long *Admiral* is a permanently moored vessel that plays host to hundreds of thousands of people each year.

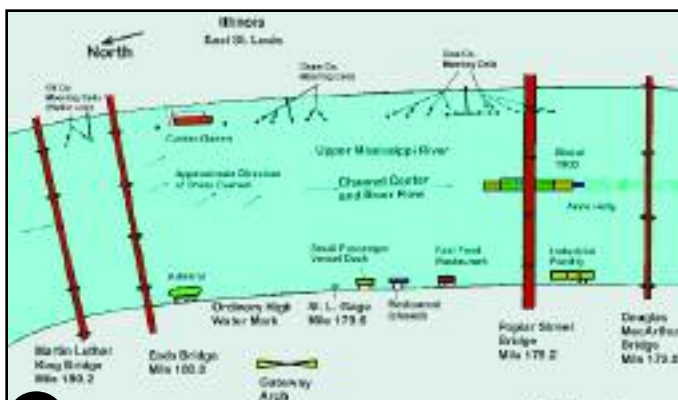
1 The *Anne Holly* crosses under both the MacArthur and Poplar Street Bridges.

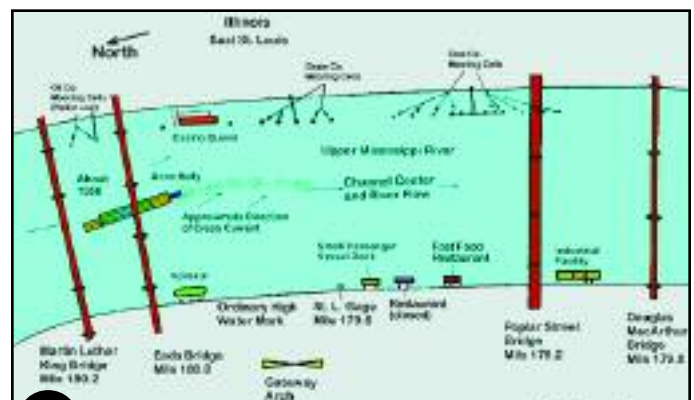
2 The vessel approaches the Eads Bridge.

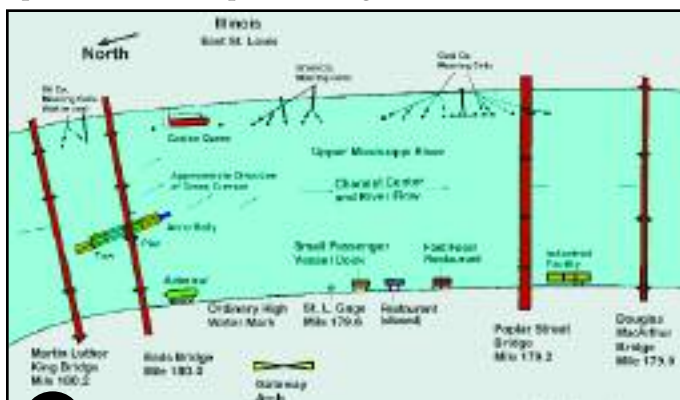
3 The only passage possible under the bridge with the increased flood stage is directly under the center span.

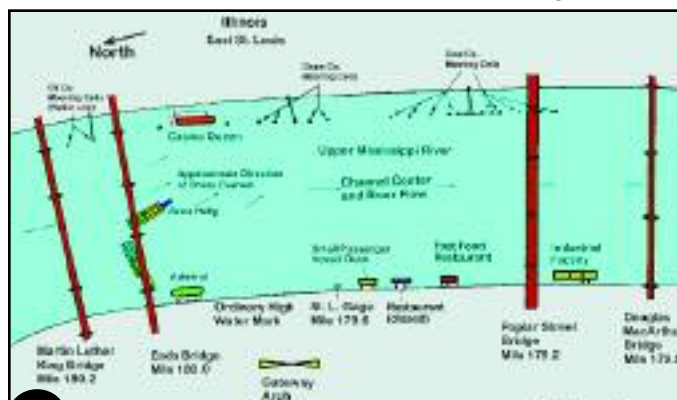
The Coast Guard and National Transportation Safety Board (NTSB) Investigation Reports, while conducted independently, both attributed the cause of the allision and subsequent breakup of the tow to poor decision-making on the part of the *Anne Holly*'s captain. They both specifically cited his failure to properly account for the prevailing currents, which led him to oversteer. According to the findings of the Coast Guard Report, "as the lead barges in the unit responded to the steering maneuver, the main downriver current acted with the increasing intensity on the unit's starboard side. Meanwhile, the cross current at the Eads Bridge, flowing in a direction opposite to that expected by [the captain], intensified the

rate of turn beyond that anticipated." The high river conditions and subsequent limited vertical clearance under the Eads Bridge during a nighttime transit were also listed as potential contributing factors.

4 Partway under the bridge the vessel stalls, and the current causes the tow to drift sideways, pushing barges into a bridge support and breaking the tow coupling.

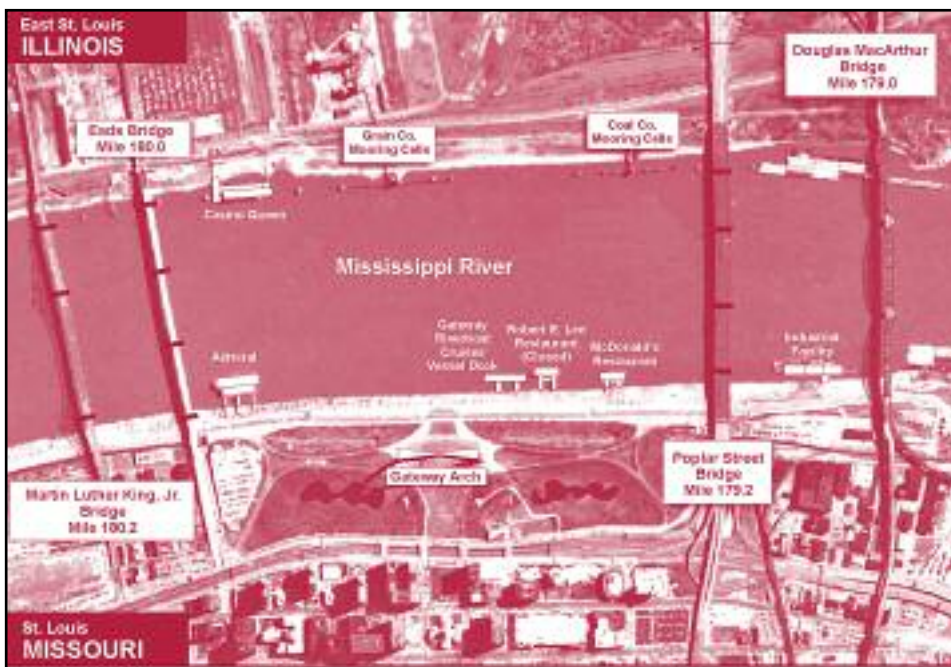
This area has long been recognized as one of the most difficult navigation areas on the Western Rivers.

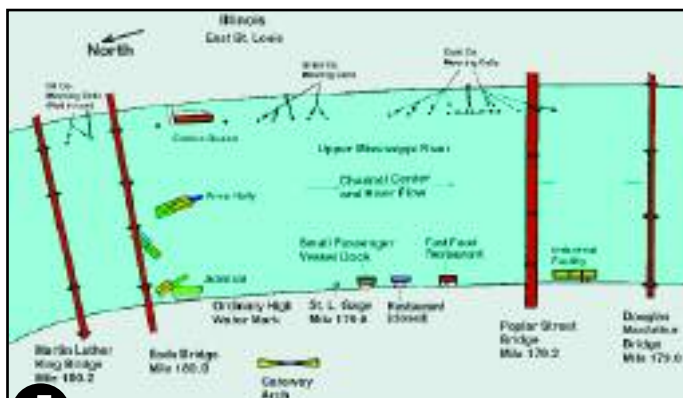
5 A number of the barges break away and drift back south.

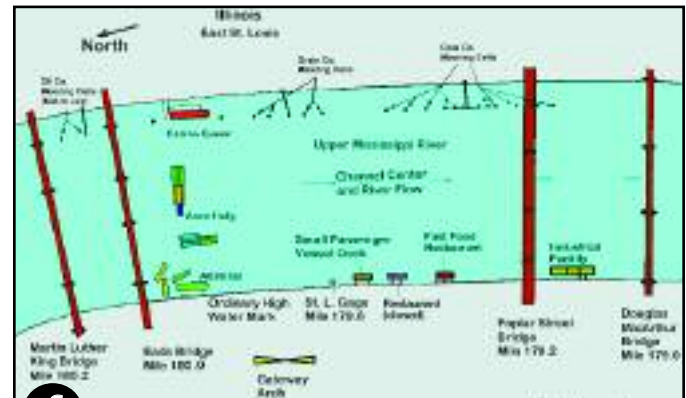
Shortly thereafter though, one or more barges allided with the *Admiral*’s bow and another struck an entrance ramp, breaking the walkway loose from its moorings. Several people on the ramp were quickly evacuated off, all of them successfully reaching the Missouri bank seconds before the ramp sank. With eight of its 10 mooring lines now parted, the *Admiral* began to rotate clockwise downriver away from the Missouri bank.

6 One or more barges allide with the *Admiral's* bow and strike an entrance ramp, breaking the walkway loose from its moorings.

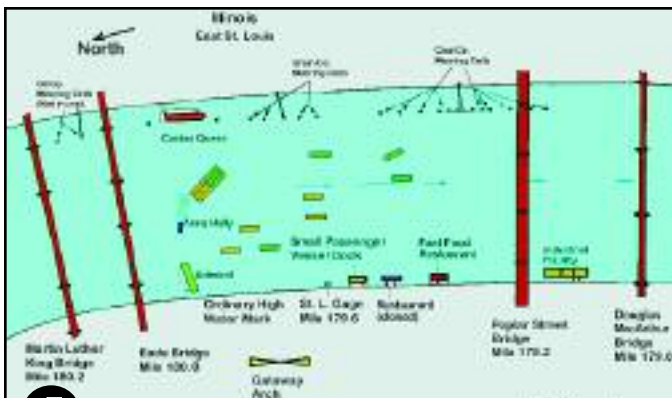
7

The captain releases the remaining barges, turns the towboat around, and places the bow against the *Admiral* as the casino’s next-to-last mooring line parts. Photos courtesy NTSB.
